**BURNED-AREA REPORT**  
(Reference FSH 2509.13)**PART I - TYPE OF REQUEST****A. Type of Report**

| <b>A. Fire Name:</b> Terwilliger | <b>B. Fire Number:</b> OR-WIF-180227 |
| <b>E. Region:</b> Pacific Northwest (R6) | <b>F. Forest:</b> Willamette National Forest |

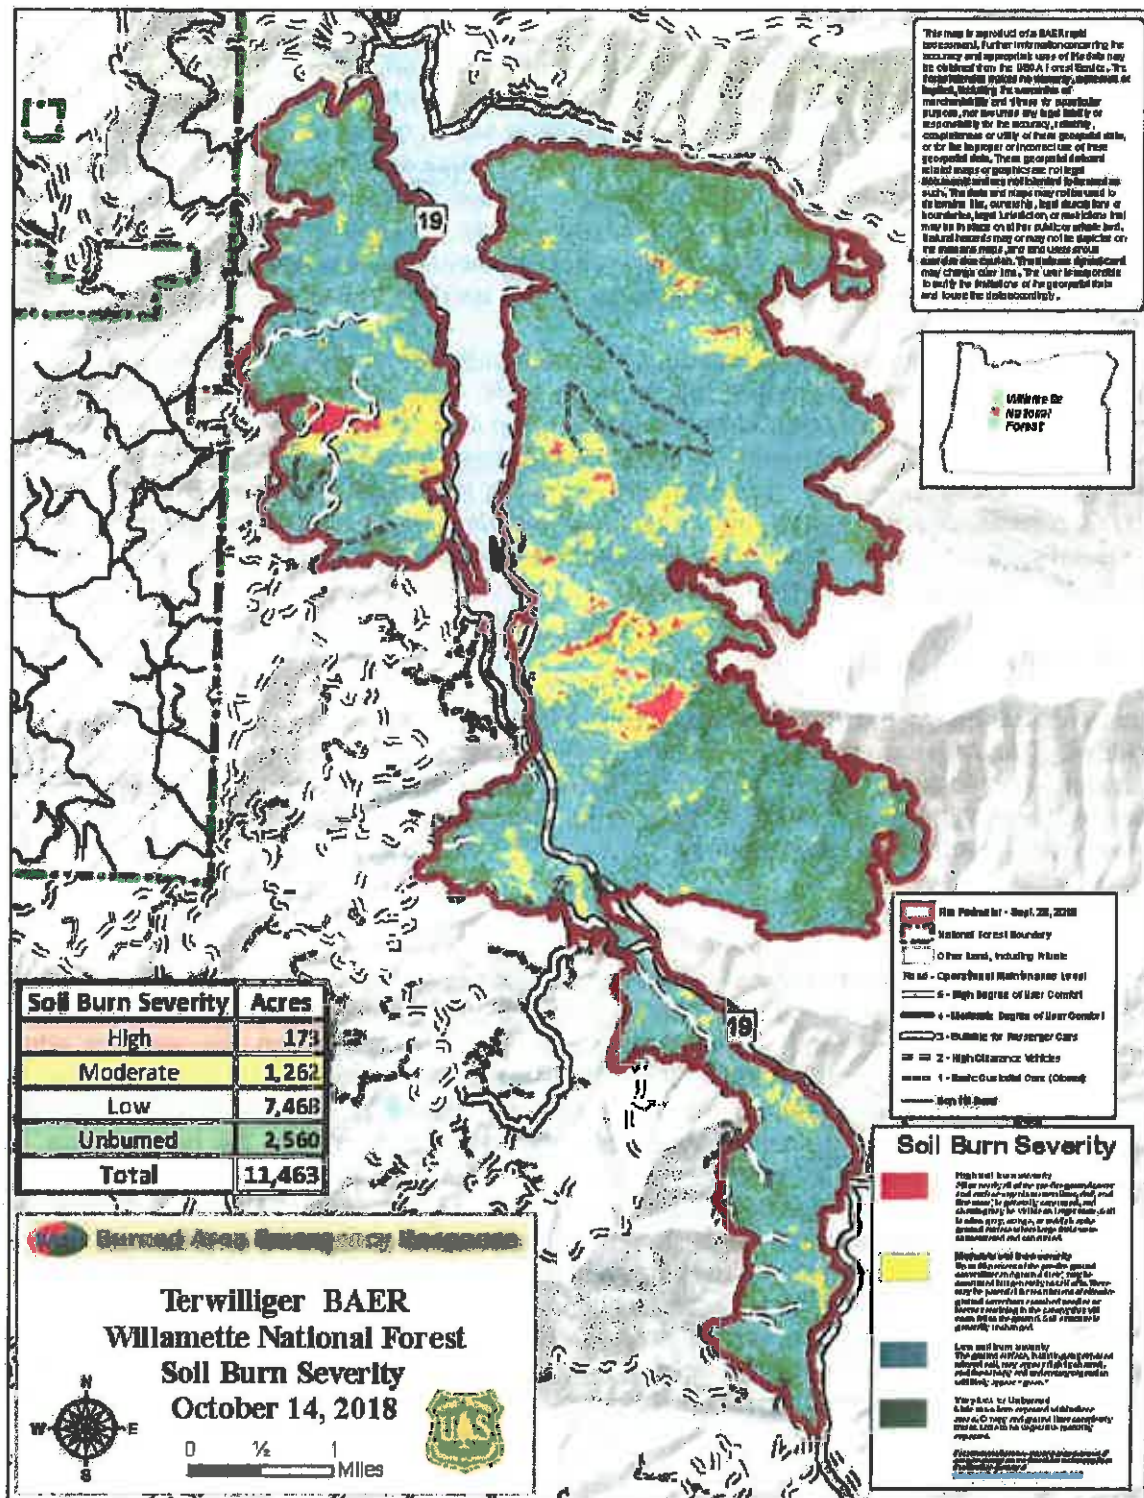
Terwilliger Fire Soil Burn Severity

<b>Soil Burn Severity</b>	<b>Acres</b>	<b>Percent of Burned Area</b>
<b>Unburned</b>	2,560	22.3%
<b>Low</b>	7,468	65.1%
<b>Moderate</b>	1,262	11.0%
<b>High</b>	173	1.5%
<b>Total</b>	11,463	100.0%
